Maryland Historical Trust

Maryland Inventory of Historic Properties number: WO-484

Name: 23013/MD 367 OVER BUNTING BR. OF ST.  
MARTIN'S RIVER.

MARYLAND INVENTORY OF HISTORIC BRIDGES  
HISTORIC BRIDGE INVENTORY  
MARYLAND STATE HIGHWAY ADMINISTRATION/  
MARYLAND HISTORICAL TRUST

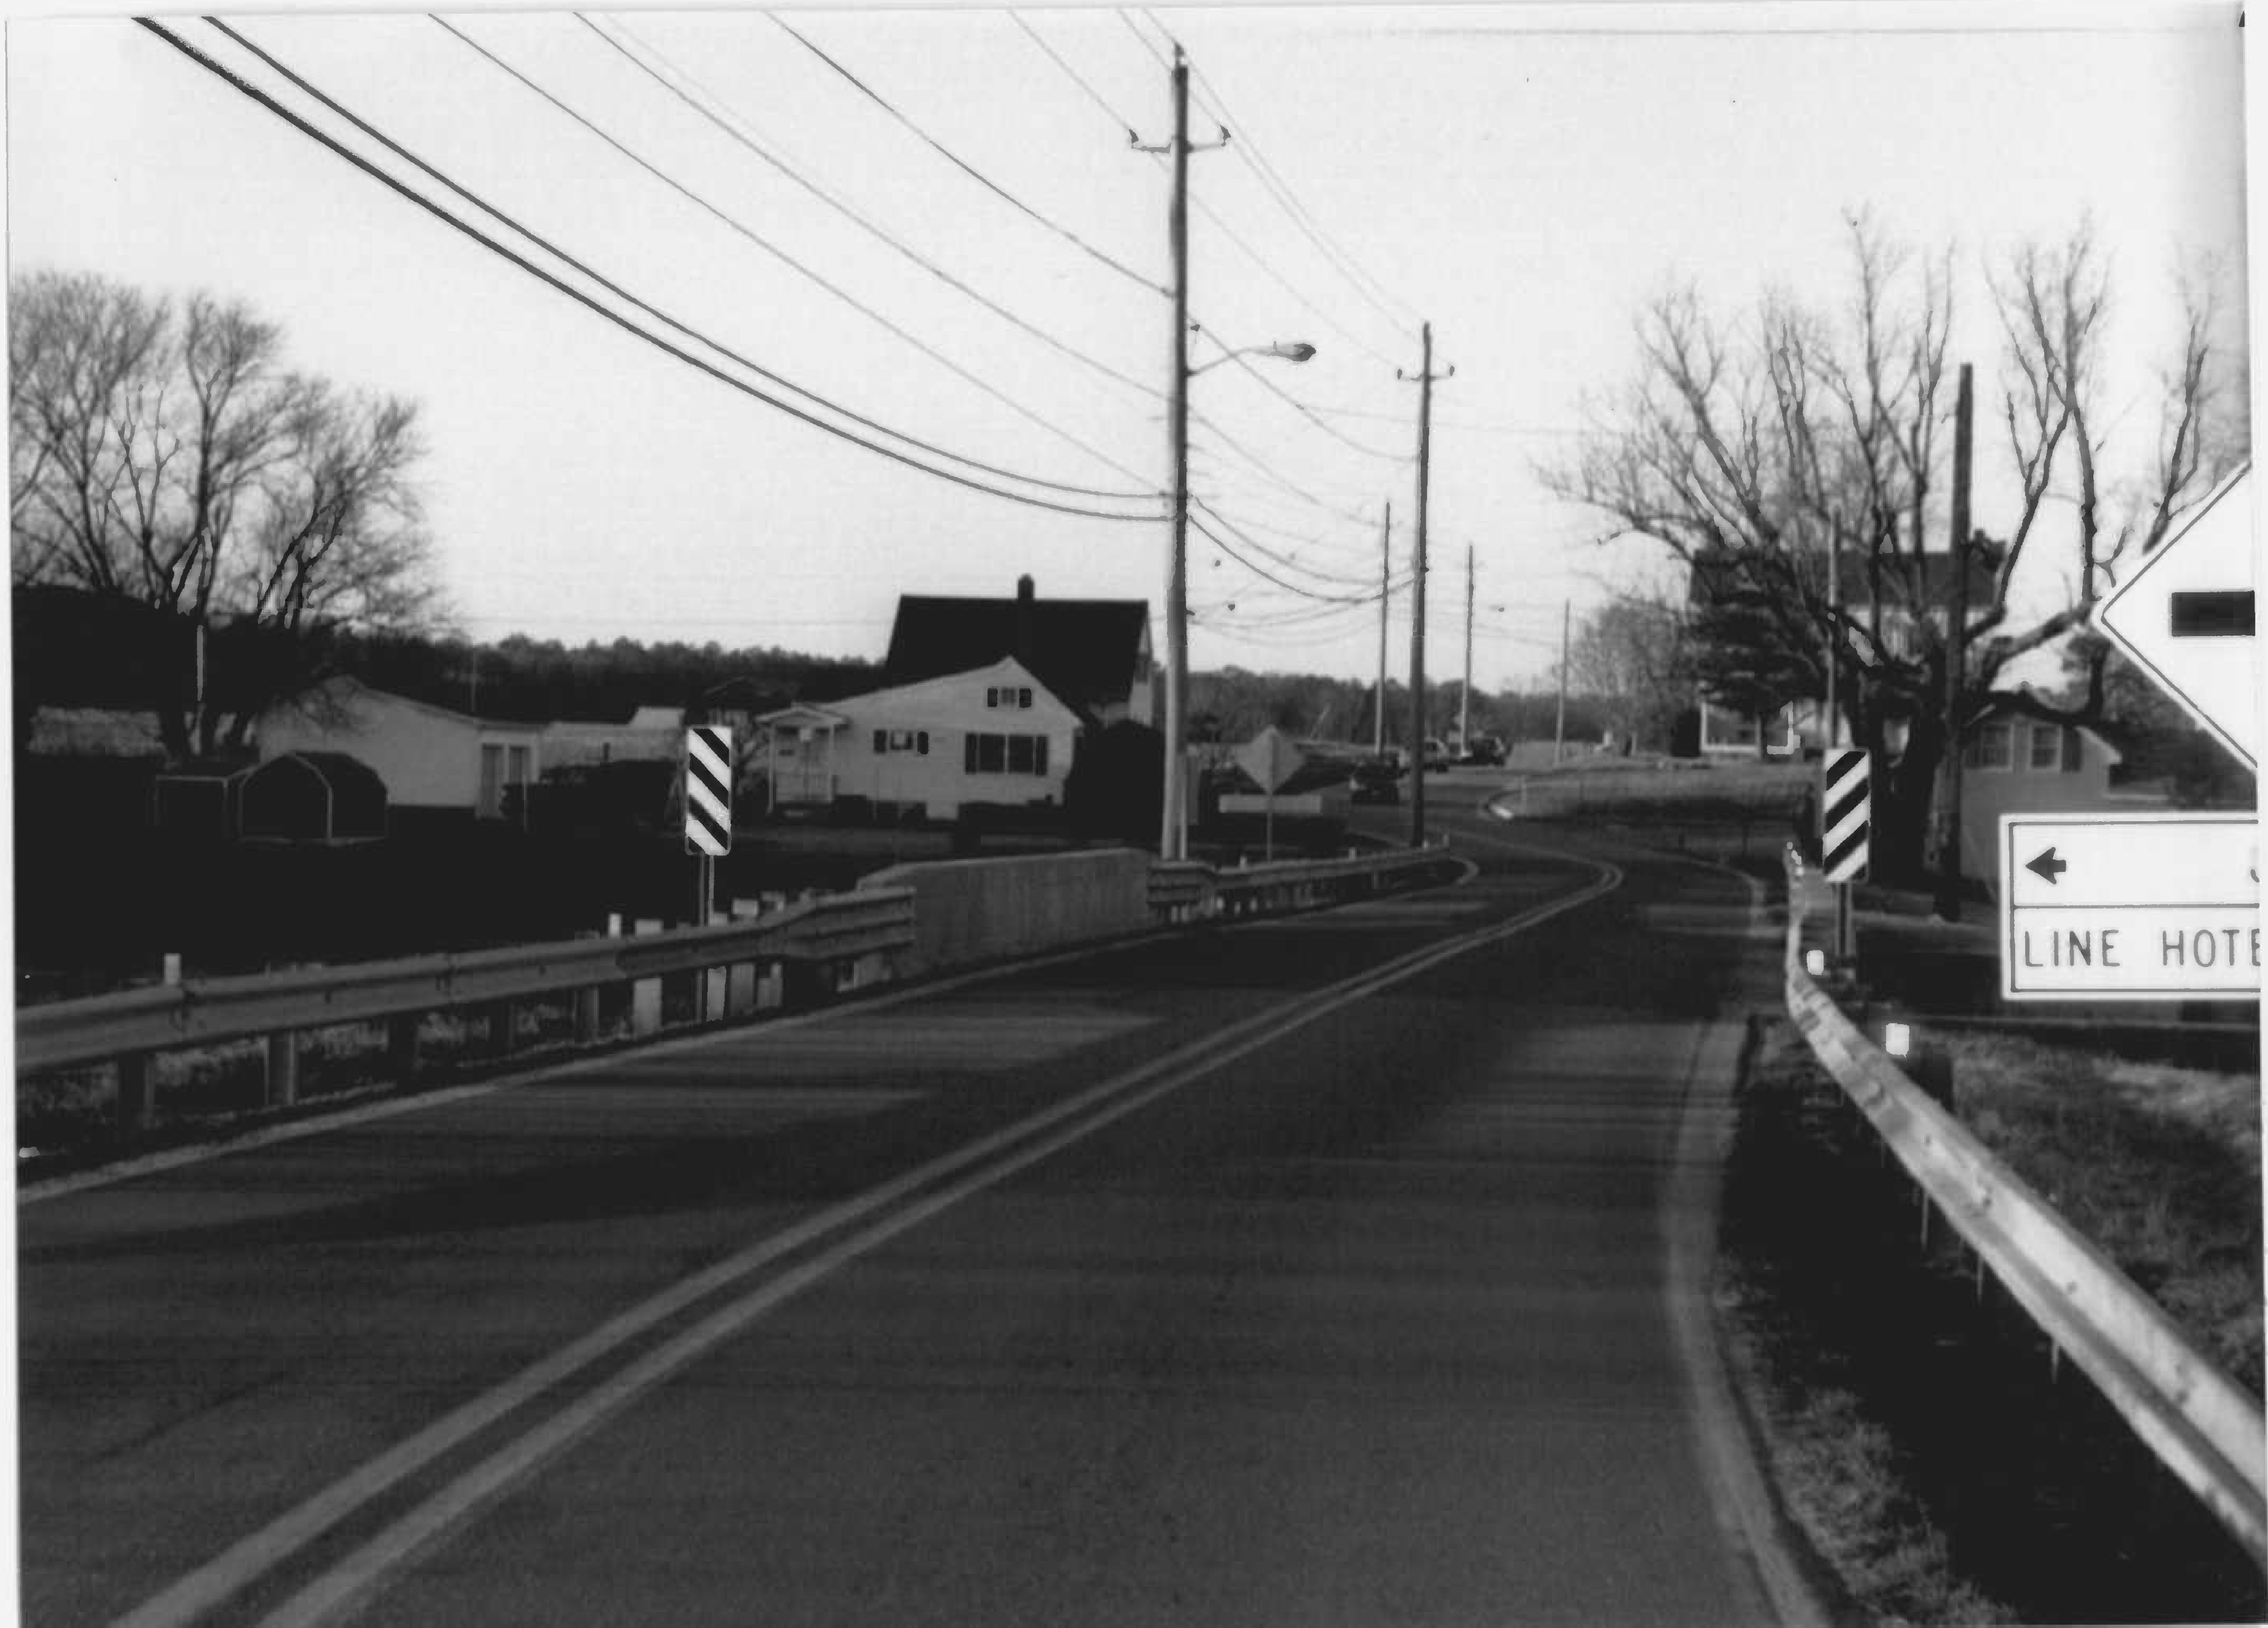
1 OF 4

BRIDGE 23013, LOOKING SW ON MD 367

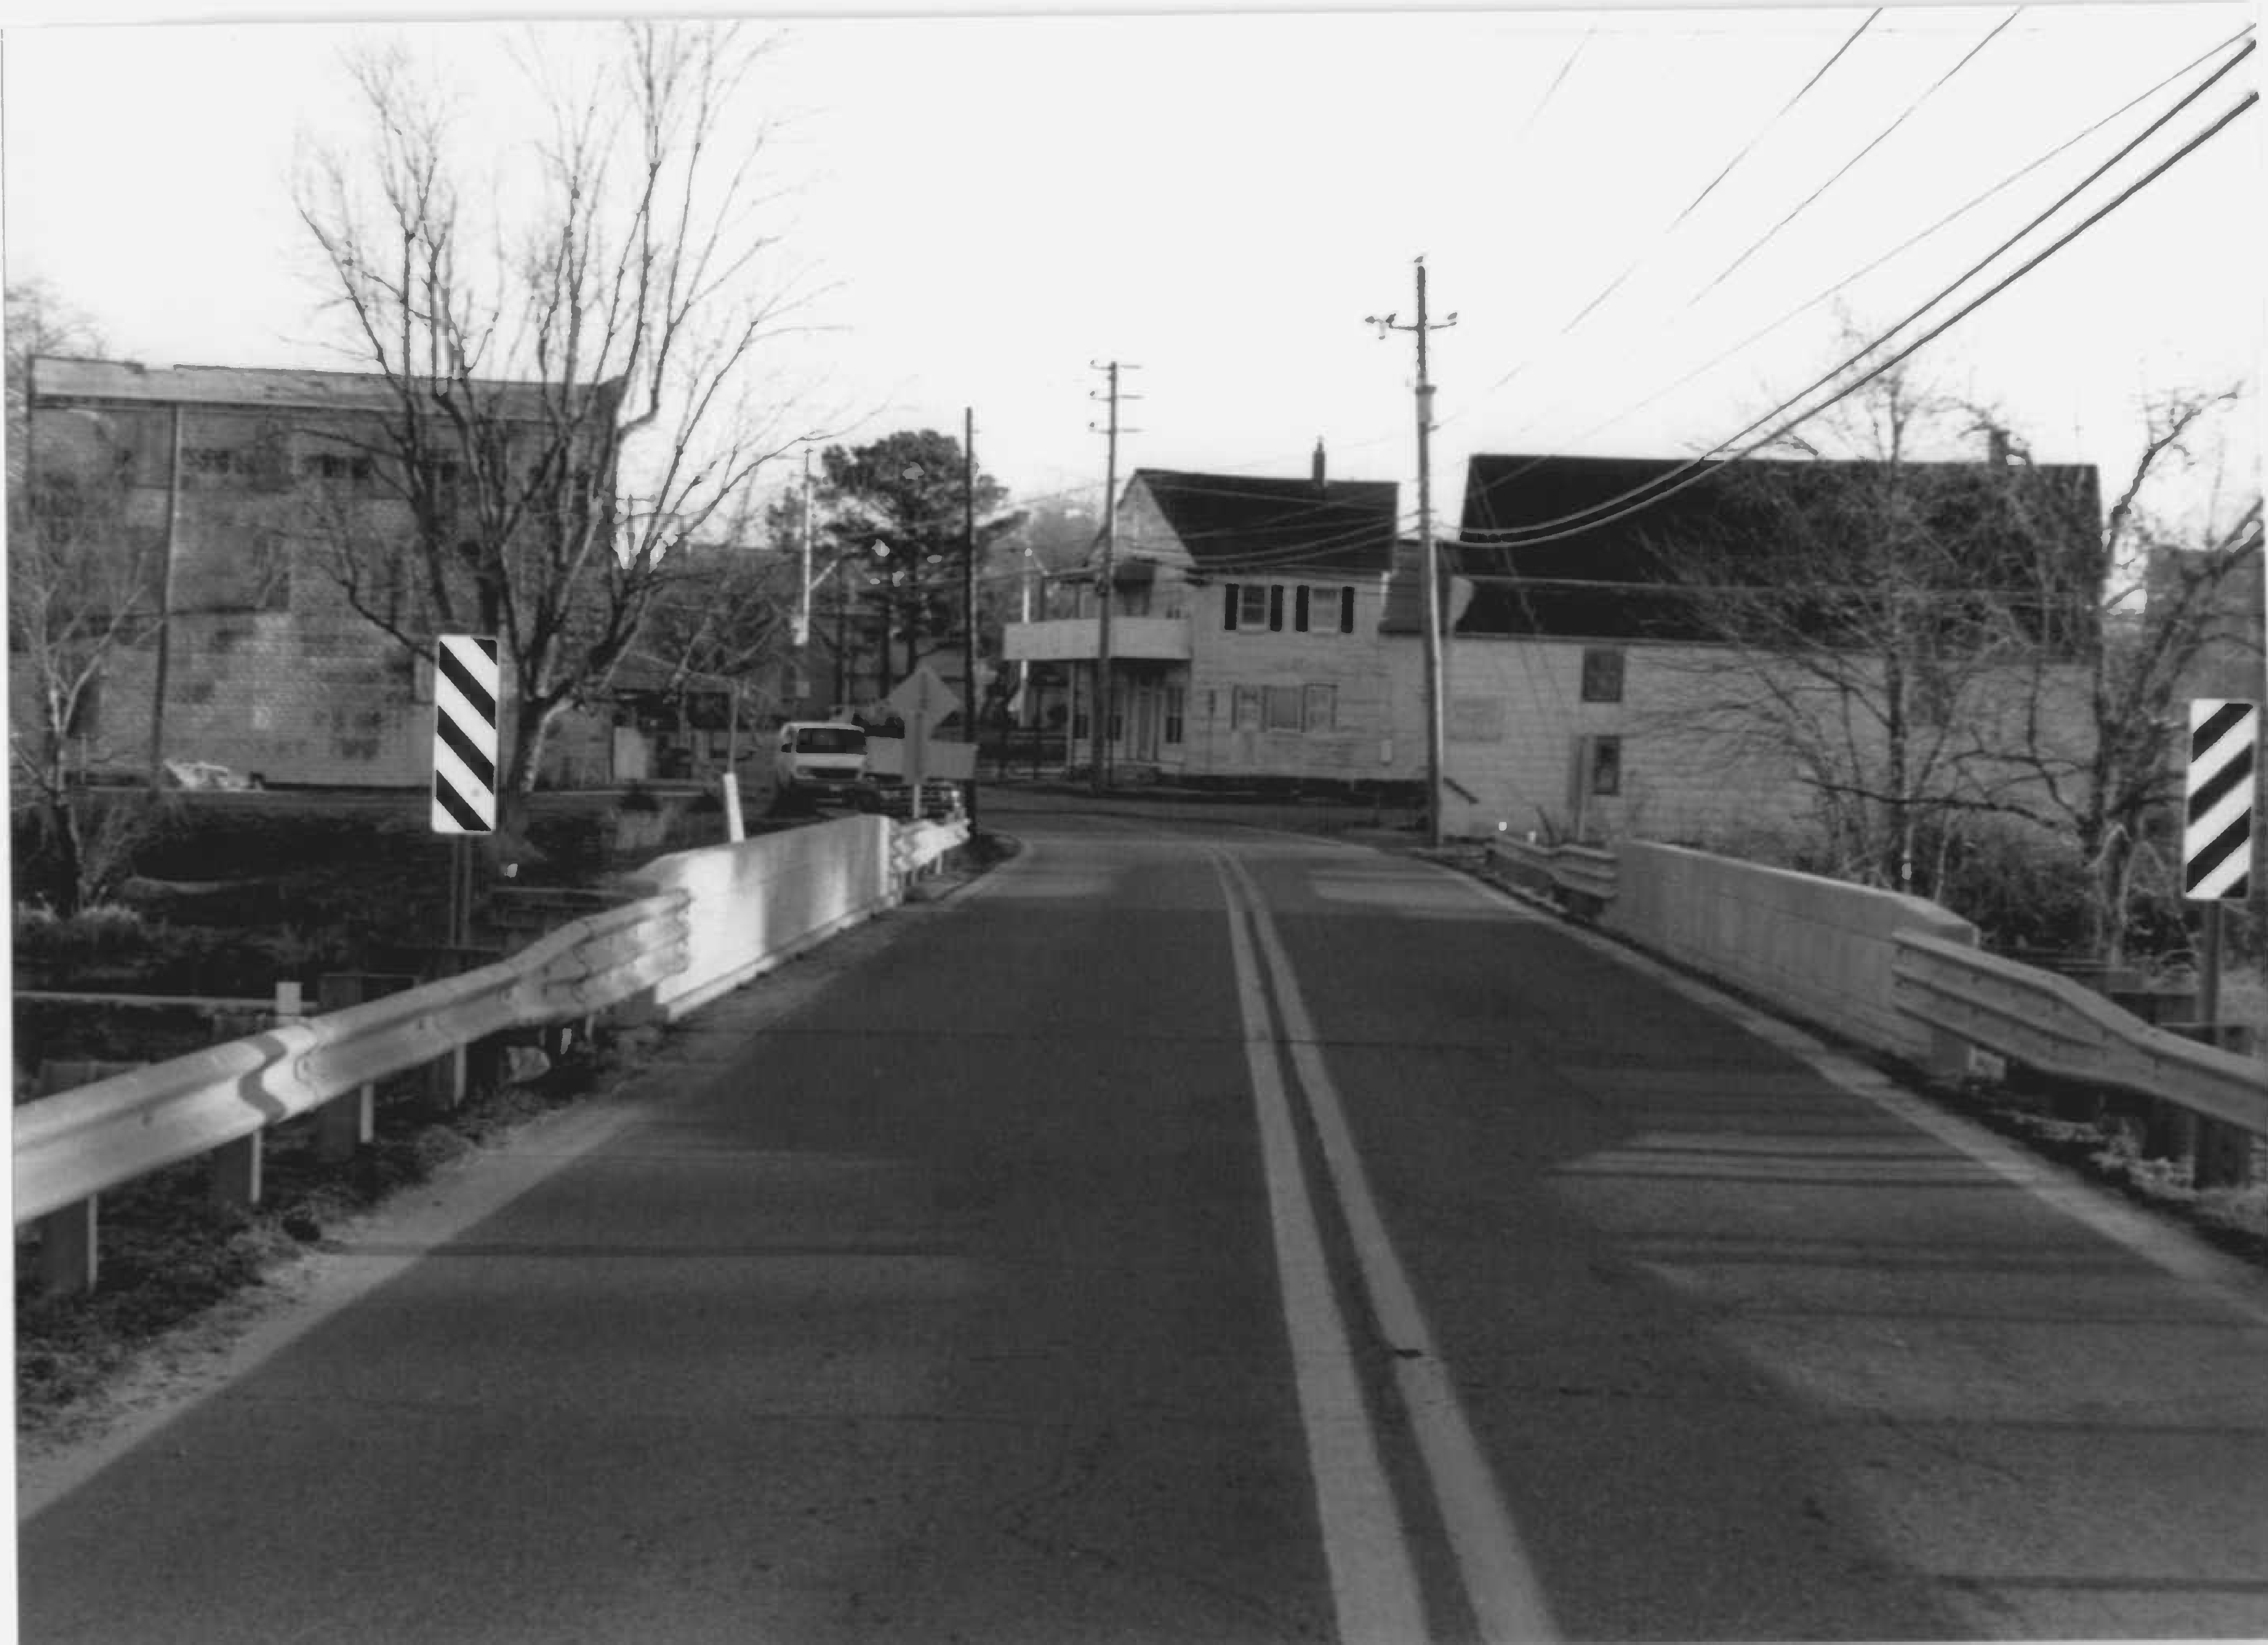
2 OF 4

BRIDGE 23013, LOOKING NE ON MD 307

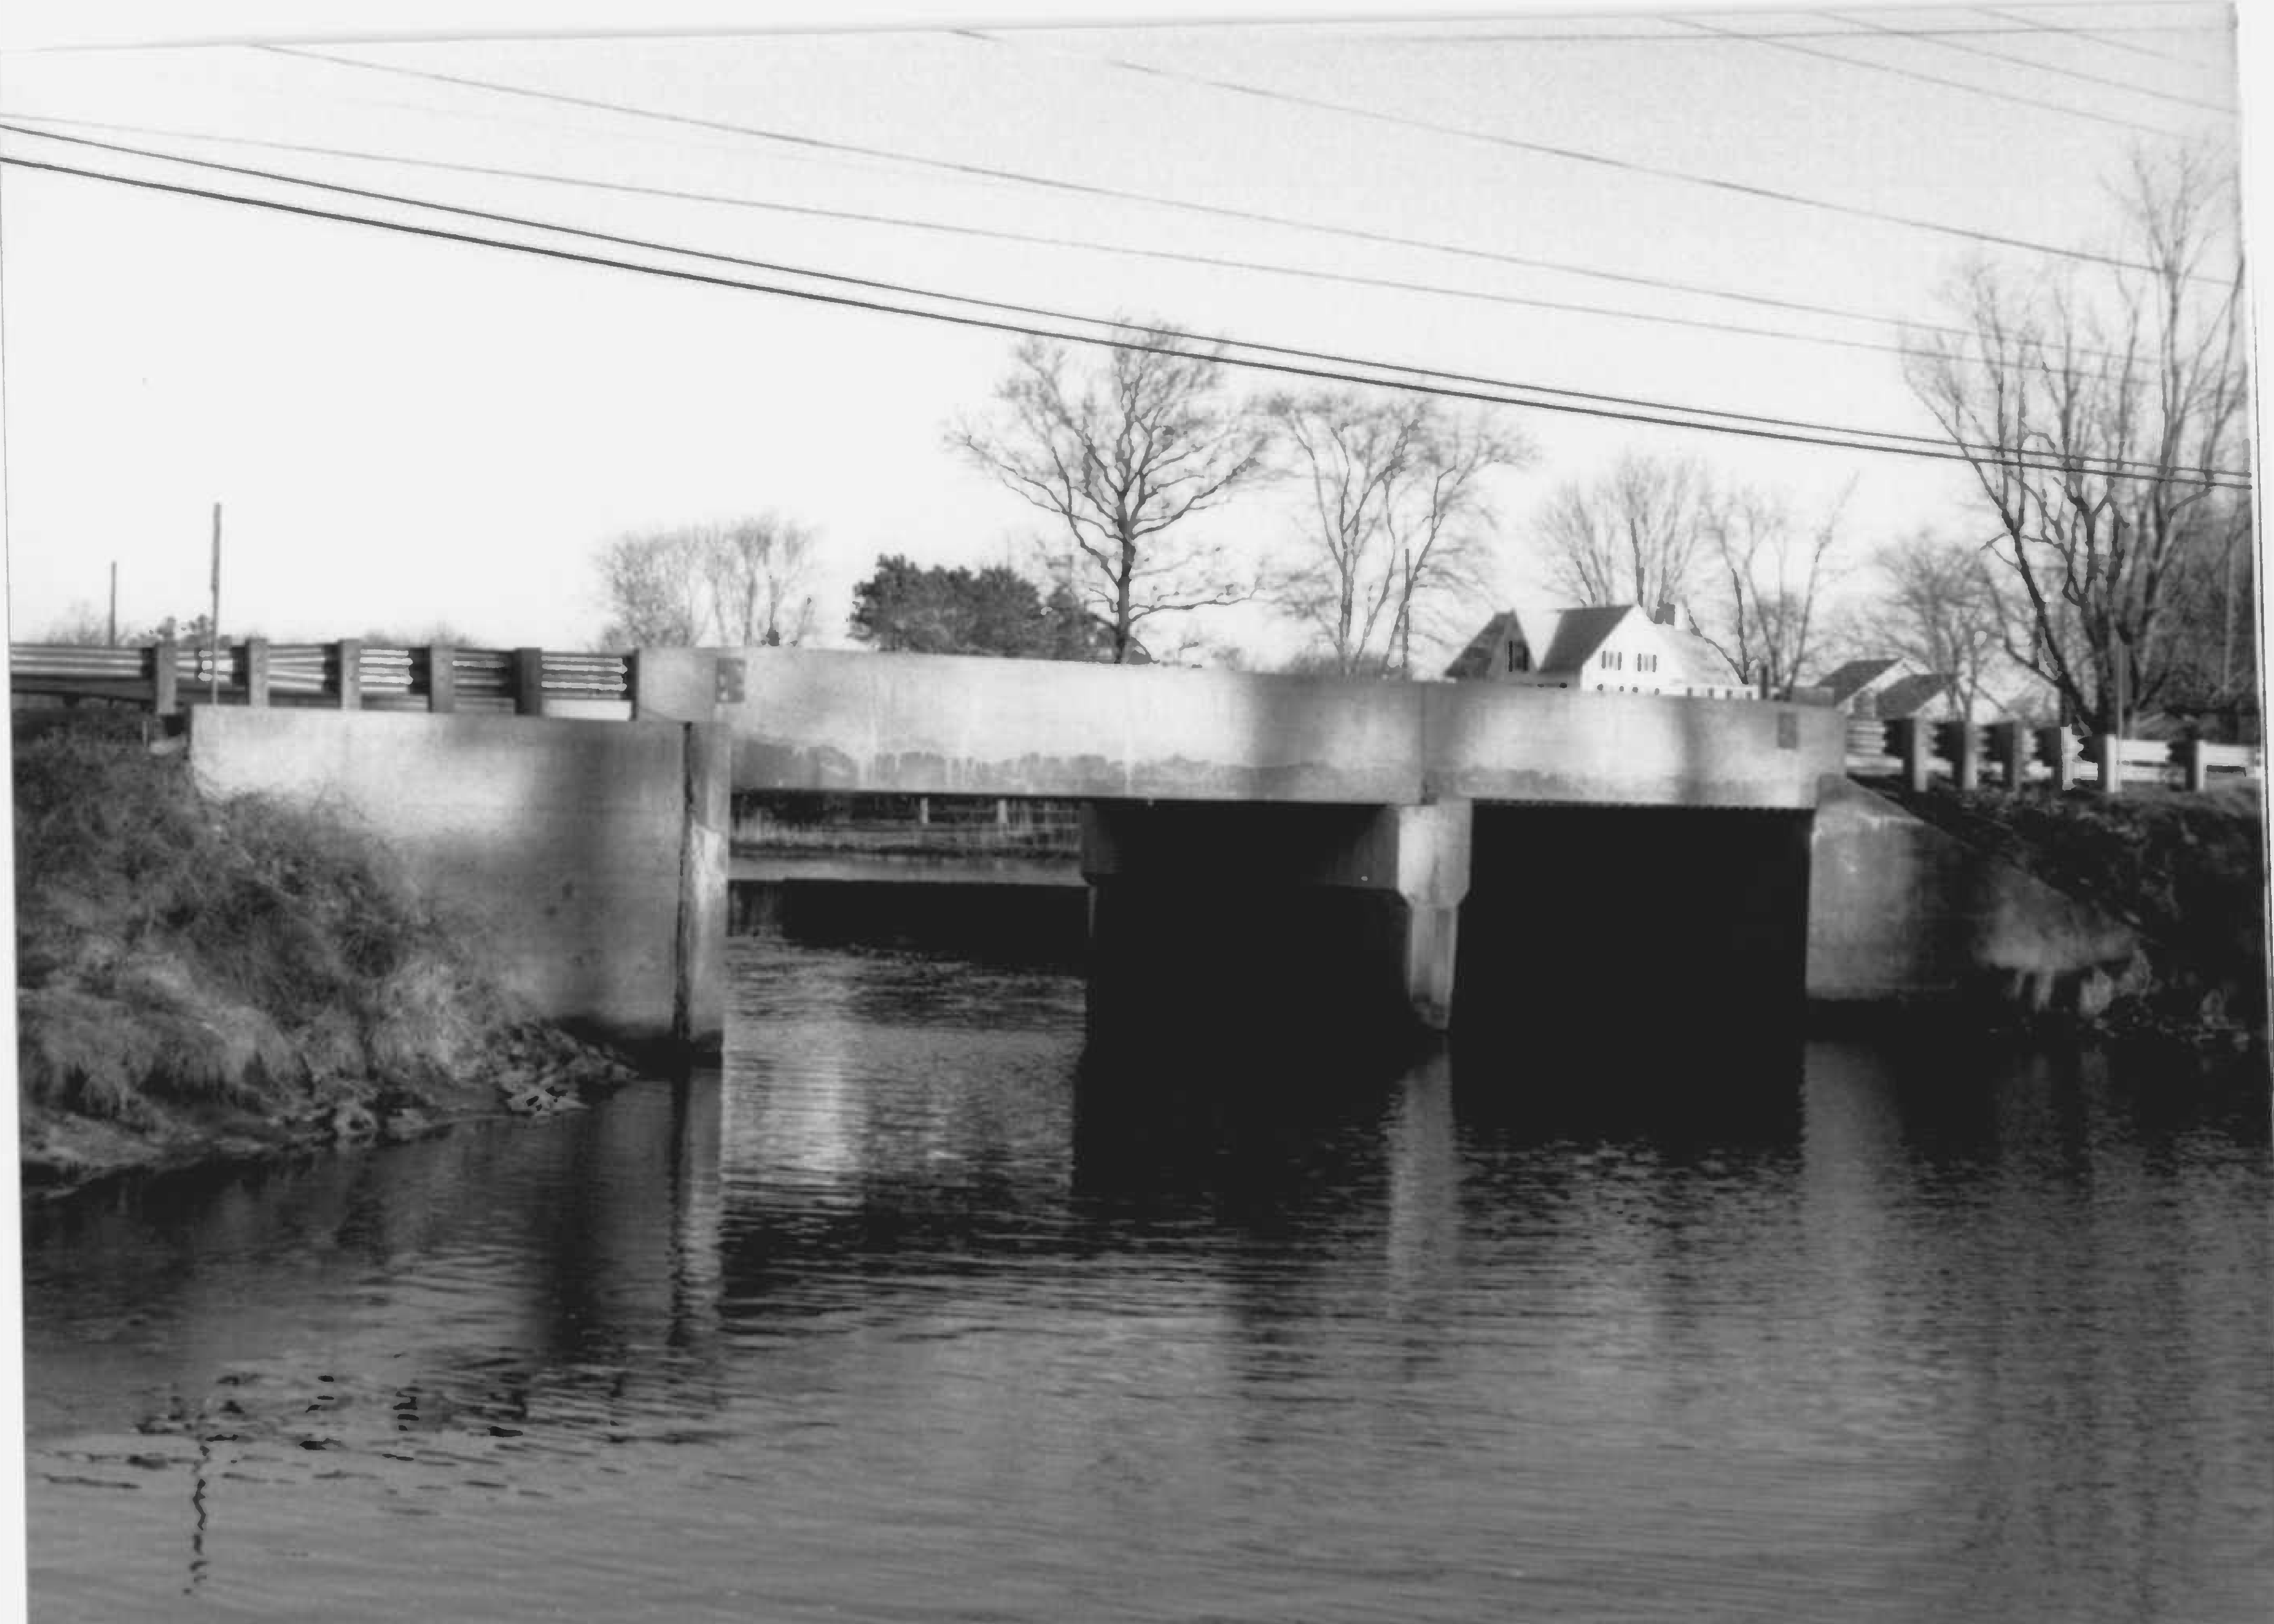
3 OF 4

BRIDGE 23013, LOOKING UPSTREAM (NORTH)

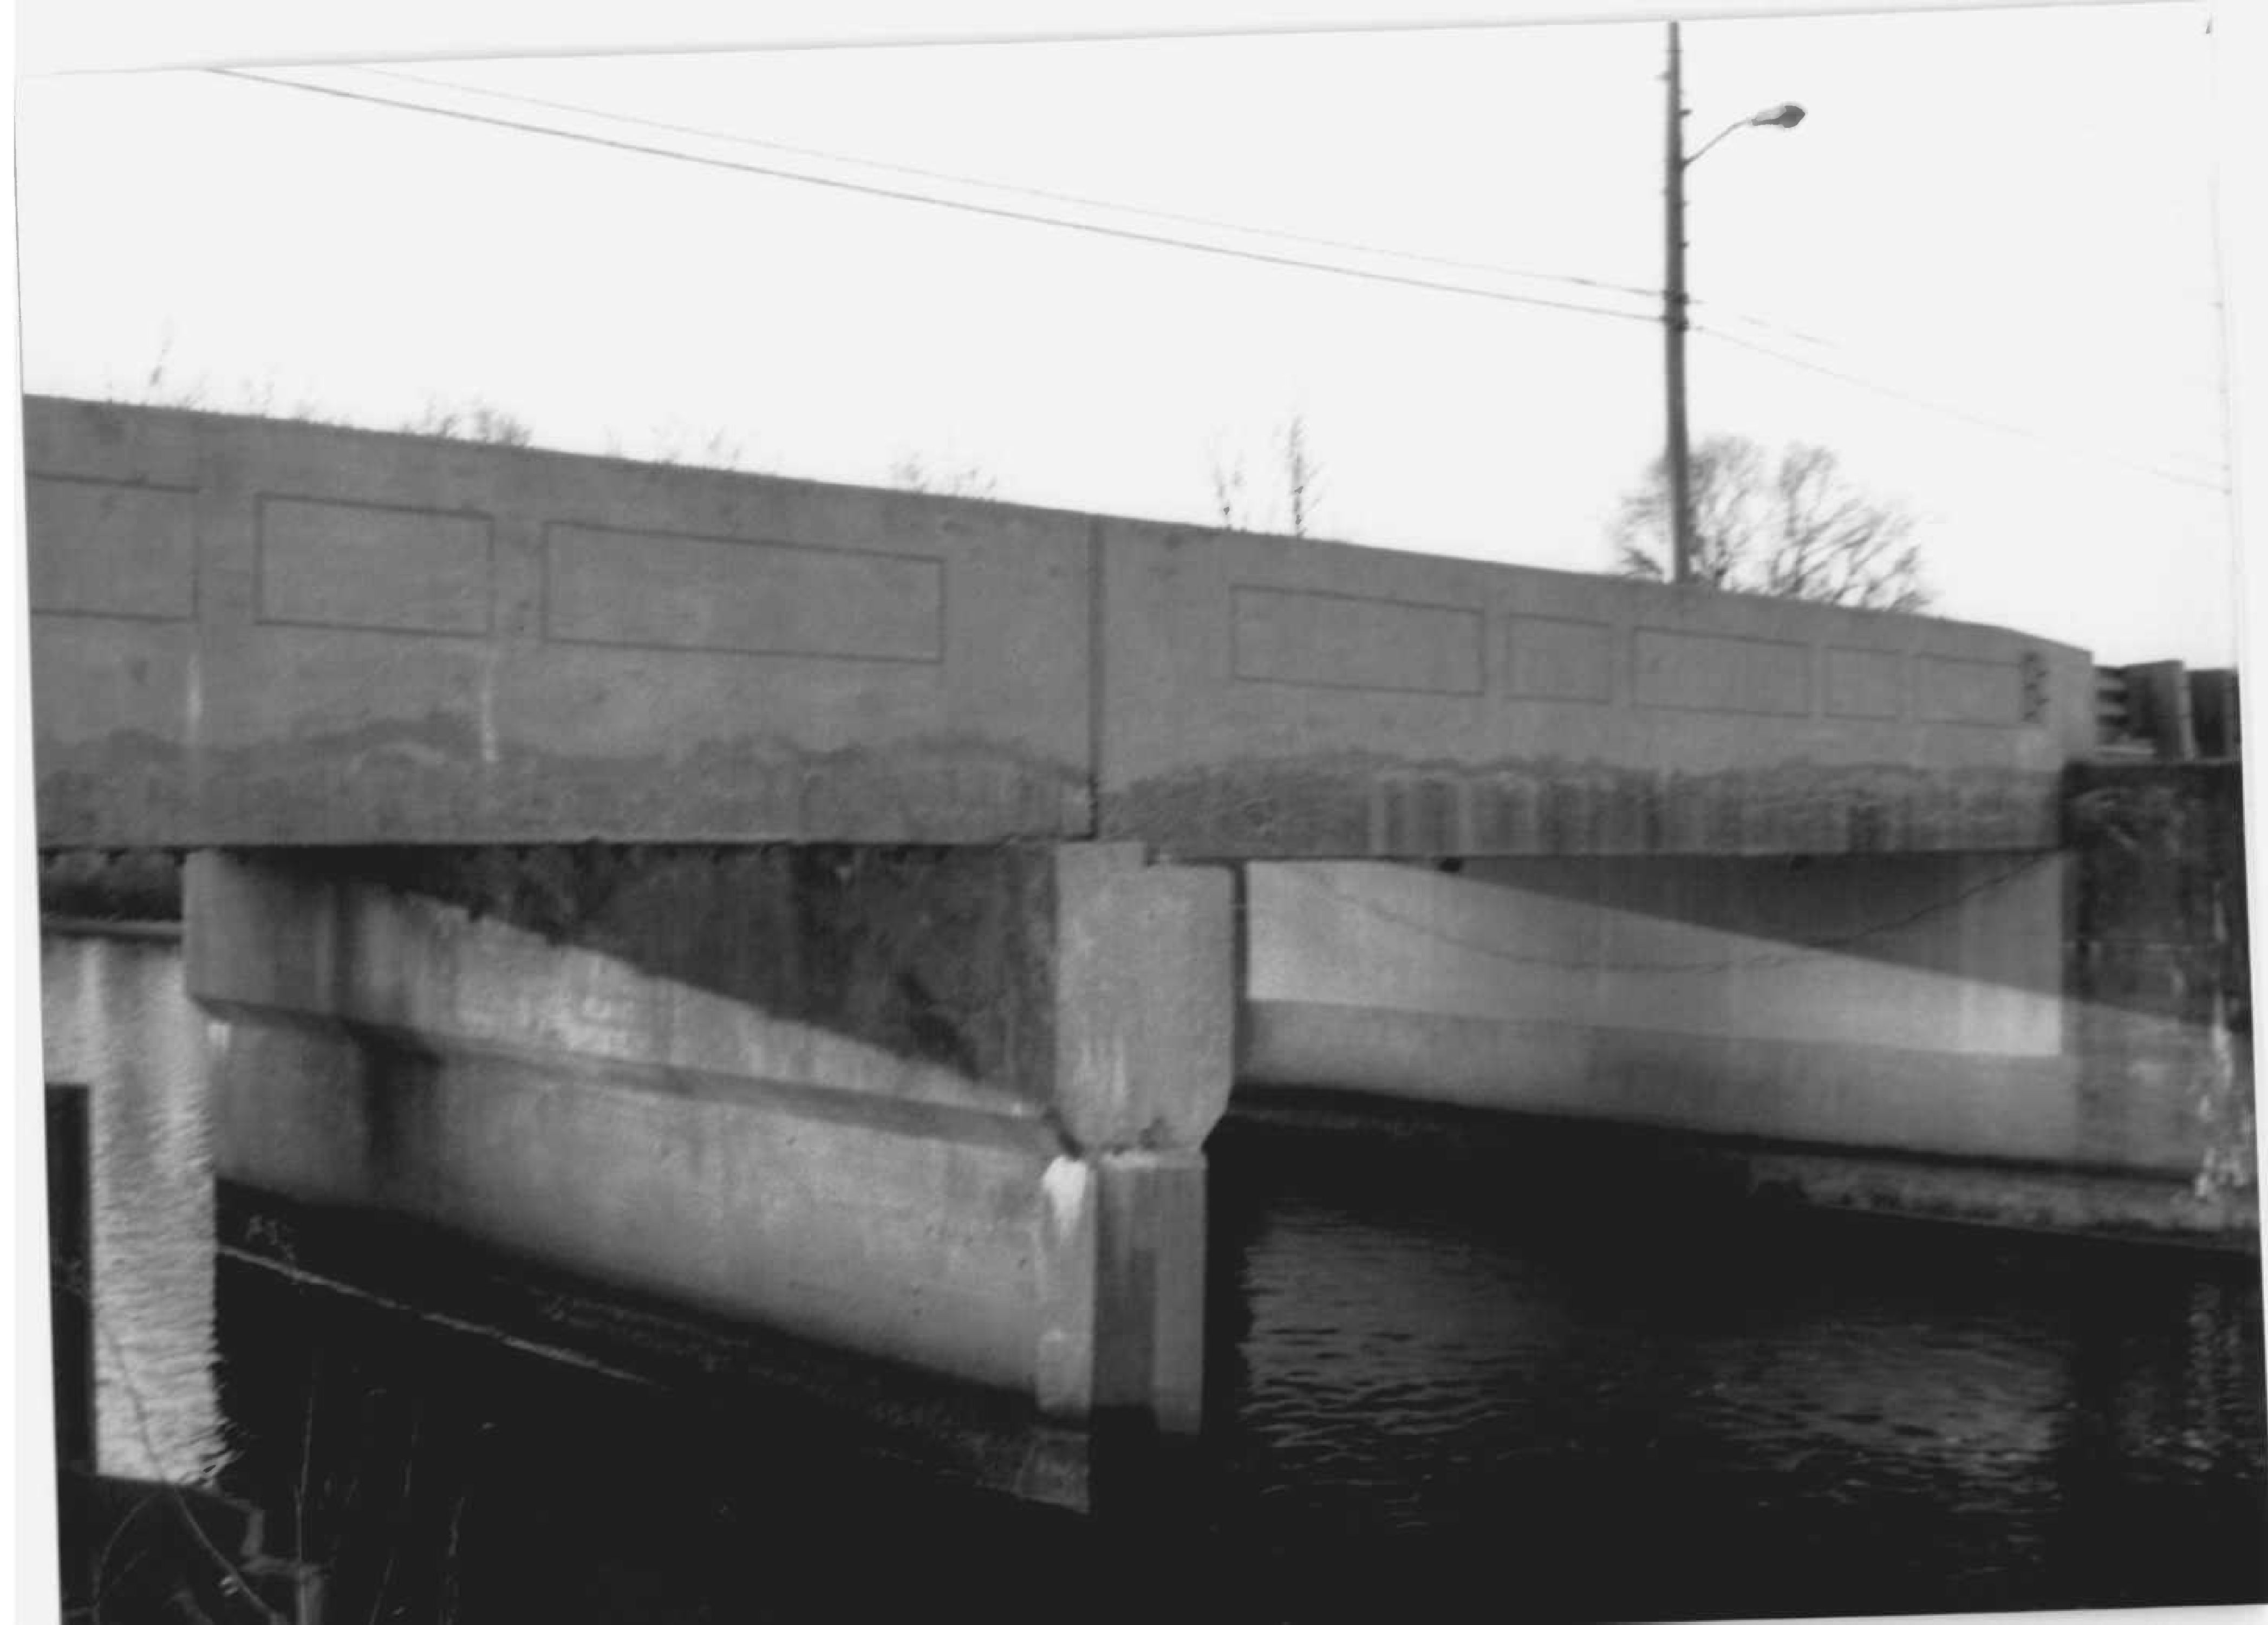
4 OF 4

BRIDGE 23013, LOOKING DOWNSTREAM (SOUTH)
